ವಿಷಯ:- ಮೈಸೂರು ನಗರದ ಜಿ.ಎಸ್.ಎಸ್. ಟೆಕ್ನಿಕಲ್ ಇನ್ಸ್ಟಿಟ್ಯೂಷನ್ ಕ್ಯಾಂಪಸ್‌ನಲ್ಲಿರುವ ಜಿ.ಎಸ್.ಎಸ್. ಪಬ್ಲಿಕ್ ಶಾಲಾ ಕಟ್ಟಡದ ಸುರಕ್ಷತಾ ಪ್ರಮಾಣ ಪತ್ರ ನೀಡುವ ಬಗ್ಗೆ.

**ULTRASONIC PULSE VELOCITY TEST & REBOUND HAMMER TEST REPORT ON IDENTIFIED
RC MEMBERS OF JSS PUBLIC SCHOOL BUILDING LOCATED AT
JSS TI CAMPUS, MYSORE**

Prepared By : Buildpoint Constructions And Technologies
Gangothri Layout, Mysuru

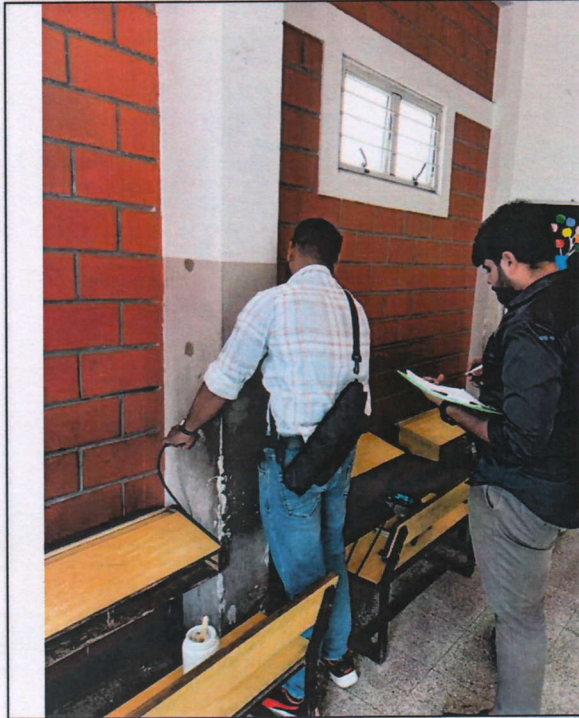
Ultrasonic Pulse velocity test on RC Column

TABLE- 1
RESULTS OF ULTRASONIC PULSE VELOCITY TEST

Members tested : RC Columns & RC Beams
 Test Instruments : Pundit Lab (Make: Proceq.)
 Technical reference : 1. Indian Standard IS: 516 (Part 5/Sec1)-2018 (Amendment–November 2019).
 Temperature of Concrete Surface And Humidity : 26.2°C/16%
 Specific Condition : Concrete surface Dry and even
 Grade of concrete : Not Furnished
 Age of concrete : More than 28 days#
 Test Conducted by : Mr. Niranjana D K- Engineer | Testing Division

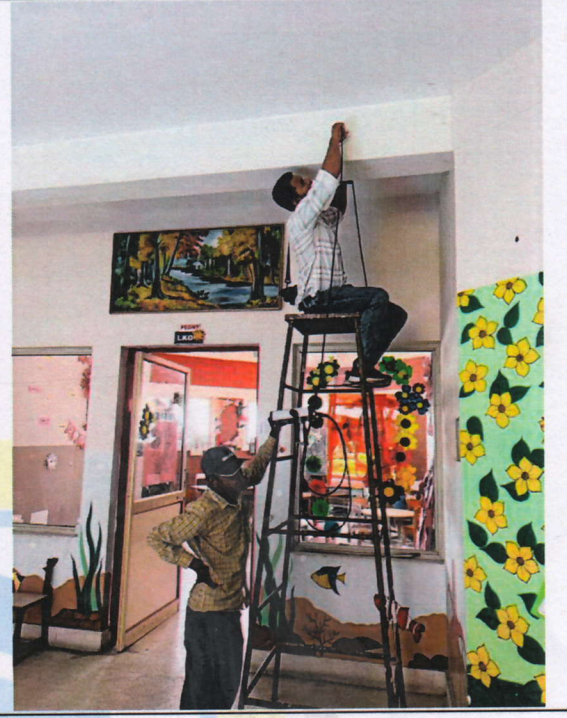
Ultrasonic Pulse velocity test on RC Beam
